LANDSLIDES AND RELATED FEATURES

OF THE BROAD BOTTOM, KY. QUADRANGLE

by
William F. Outerbridge
1982

U.S. Geological Survey
OPEN FILE MAP 82-51 (E-12)

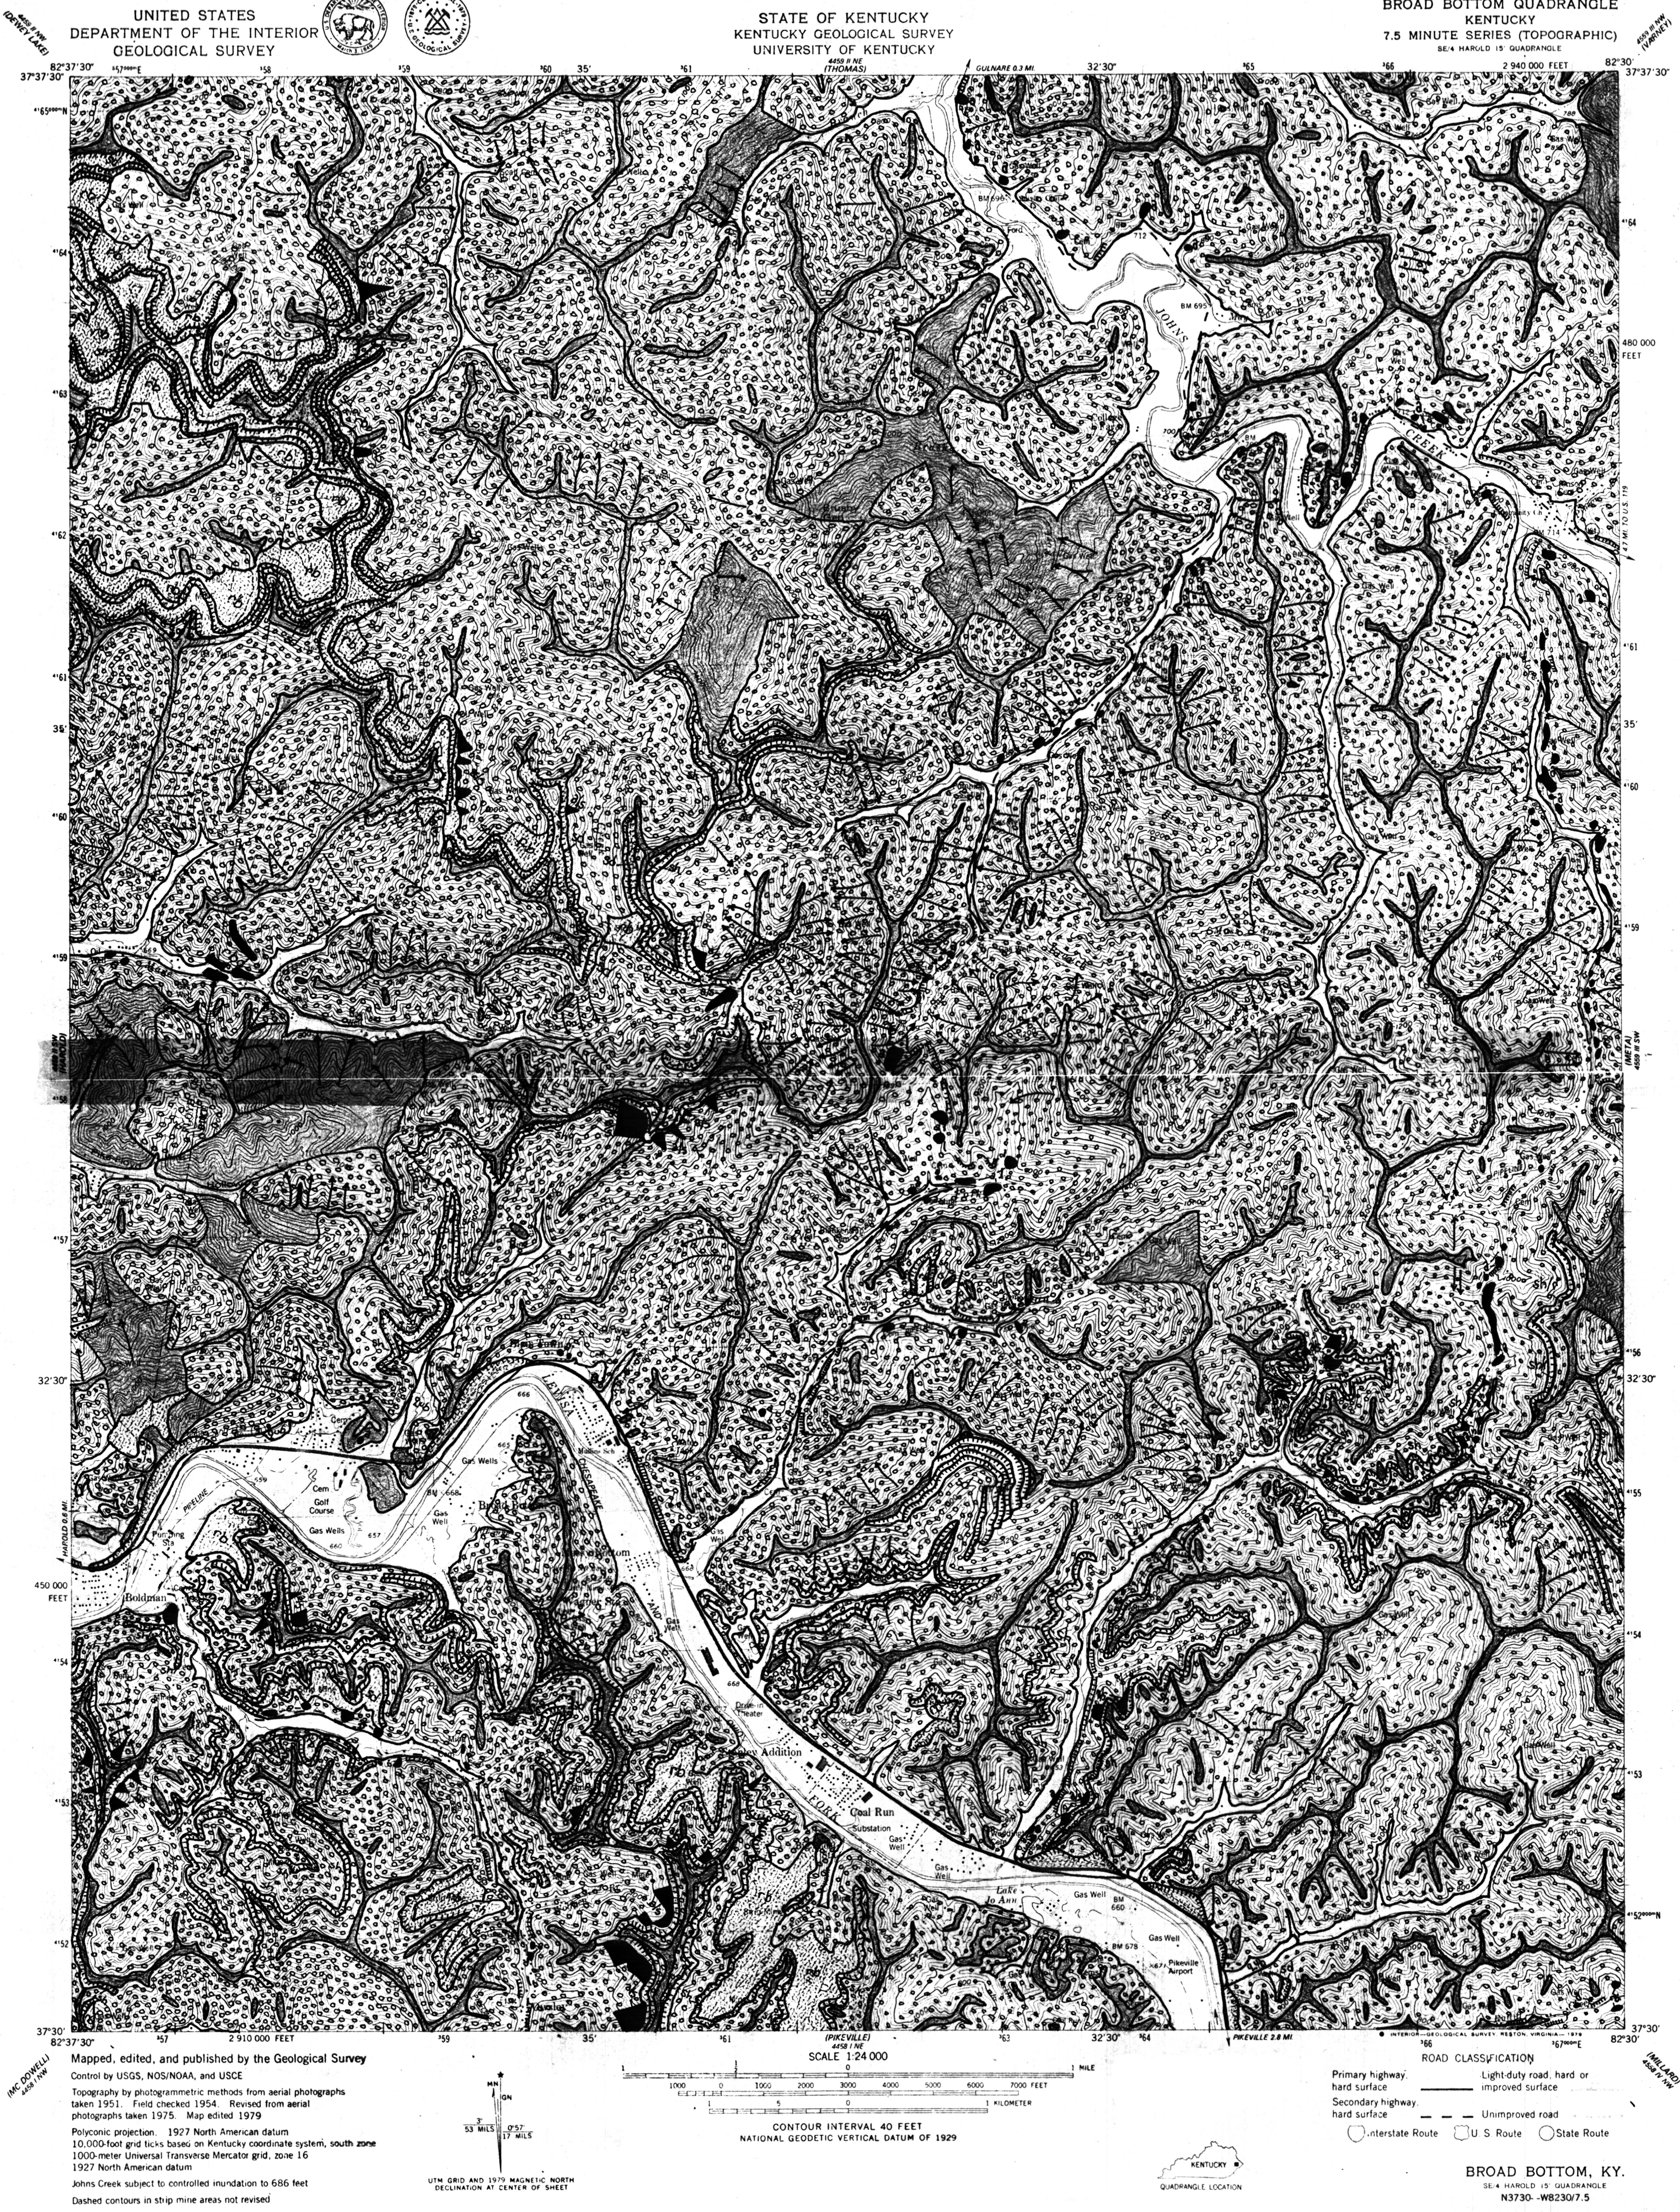
BROAD BOTTOM, KY.
SE 4 HAROLD 15 QUADRANGLE
N3730-W8230/7.5
1979

Information shown is intended as a general guide to ground conditions as of the date of field check. Additional landslides and rockfalls should be anticipated in all map units. The map unit depicts the dominant condition in the area delineated and variations in slope stability may occur at any point in the unit. This map is suitable for general planning purposes and as a supplement to more detailed studies for site selection. The map cannot be used as a substitute for detailed geologic and engineering investigations to establish design and construction criteria of specific sites. Some symbols may not appear on this map because the description is applicable to a series of maps.

ACTIVE OR RECENTLY ACTIVE LANDSLIDE
Complex landslide composed of earthflow, debris slide, earth and rock slump. Identified from historical records, and from scars, debris and other field evidence. Ground extremely unstable; sliding accelerated by excavation, loading and changes in drainage conditions. May include areas with several active slides too small to be shown separately. Questioned where doubtful.

OLD LANDSLIDE
Area of extensive hummocky ground caused by earthflow and earth and rock slump. Lacks clear evidence of active sliding. Relatively stable in natural, undisturbed state, generally not affected by small structures properly sited in areas away from the edge of the toe; can be reactivated by extensive, rapid excavation, loading, and changes in ground water and surface water conditions. Area of old landslide probably includes recent ones not identified from field evidence or otherwise documented. Upslope boundary of landslide generally defined by modified scarp, but downslope (toe) may be gradational and not well defined. Questioned where doubtful.

COMBINATION LANDSLIDE
Area of recent and old slides in which individual slides are not identified.

COLLUVIAL SLOPE
Valley wall along major streams with slope as steep as 40° (85%); stony, clayey silt soil up to 50 ft. (15 m) thick; commonly buttressed by a terrace or bench at the toe of the slope; very susceptible to sliding by cutting of toe area, removal of terrace or bench, and overloading; slide commonly activated without apparent cause.

COLLUVIAL SLOPES WITH LANDSLIDES
Landslides too small or obscure to map individually.

AREAS SUSCEPTIBLE TO DEBRIS FLOWS AND DEBRIS AVALANCHES
Primarily shallow, narrow ravines and chutes with accumulation of stony colluvium generally 10 ft. (3 m) or less in thickness; susceptible to rapid movement during intense rainfall. Most ravines and chutes designated show evidence of former debris flows and avalanches. Symbol & designates historical debris flow or debris avalanche.

AREAS SUSCEPTIBLE TO ROCKFALL
Steep, locally vertical, natural and man-made slopes and cliffs, 15 ft. (4.5 m) or more high; formed dominantly of sandstone, limestone, sandy shale, mudstone and claystone. Interbedded mudstone, claystone and shale weather rapidly leaving sandstone and limestone rock faces unsupported.

SOIL AND ROCK SUSCEPTIBLE TO LANDSLIDING
Soil and rock similar to that involved in landslides elsewhere in map area; primarily areas underlain by claystone, mudstone and shale associated with other rock types. Rock weathers rapidly on exposure forming clayey soil highly susceptible to sliding. Includes coves (U-shaped, shallow valleys) containing thick layers of clayey soil that are very susceptible to sliding where excavation breaks continuity of slope and where overloaded by artificial fill.

AREAS LEAST PRONE TO LANDSLIDES
Map areas in which no patterns or symbols are shown; primarily valley floors, ridge tops and broad benches; modification by excavation and fill may lead to local landslides.
